SLOPE STABILISATION

near Loskopdam

Rehabilitation of national route N11, section 10 going from Middelburg towards Groblersdal near Loskopdam (km 23,5 to 53,4). Cut 5, 6, 7 and 8.

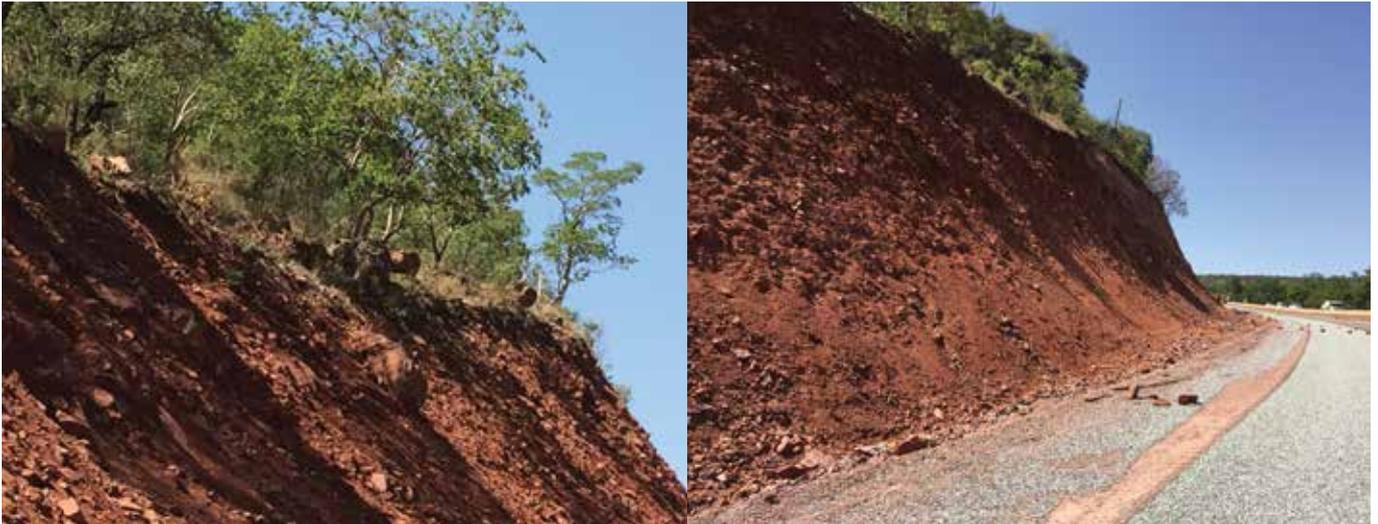
Work on the slope stabilisation near Loskopdam started as early as September 2015 and was completed earlier this year. Infrastructure engineers, HHO Africa, recommended a draping mesh of 2,7 mm diameter hot-dip galvanised hexagonal woven double-twisted wire mesh with 80 mm x 100 mm mesh opening or equivalent high-tensile steel mesh.

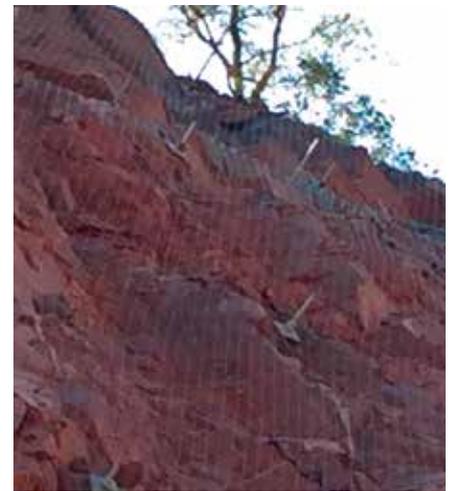
Contractors Guncrete (currently Guncrete Geotechnical), opted to use Geobruigg's Deltax G80/2 mesh. Deltax mesh has lower installation cost as compared to commercially available double twisted mesh. At only 76 kg per 117 m² roll of mesh (hexagonal mesh is more or less 164 kg for the same size), the mesh rolls can be handled by hand with only a few workers.

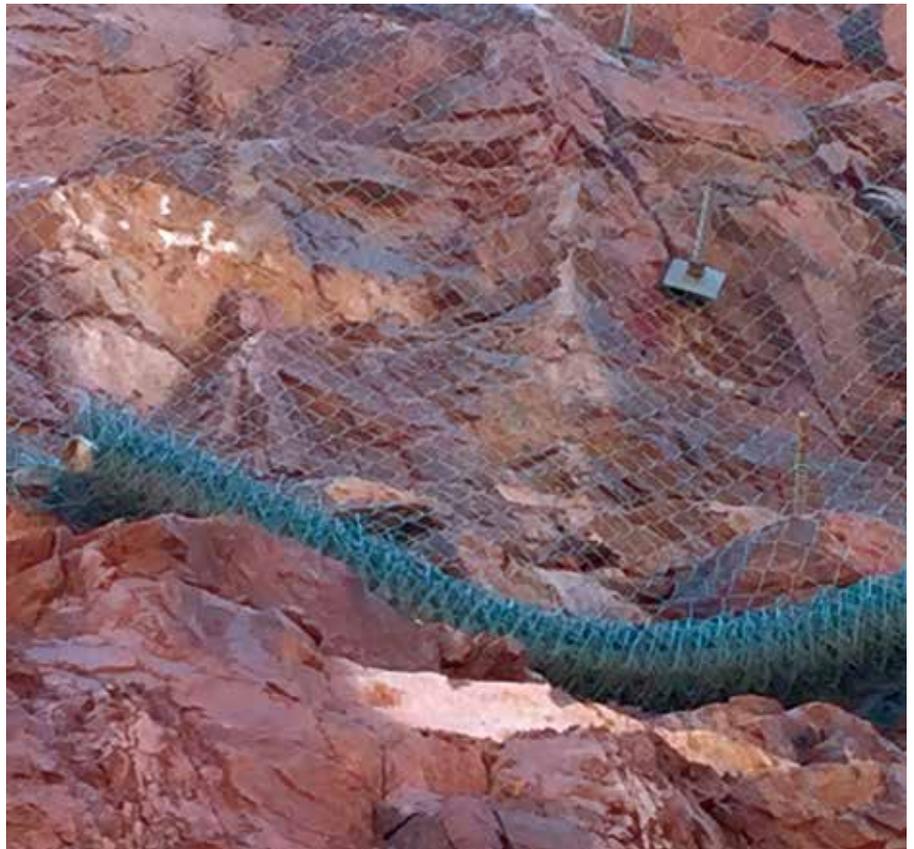
The contractor on site, KPMM made sure that the work was done as per the design specifications. After barring down the face, the mesh and dowels (25 mm, length 1 200 mm) were installed in areas where the ground was fractured, or there were infilled joints and steep gradient. →

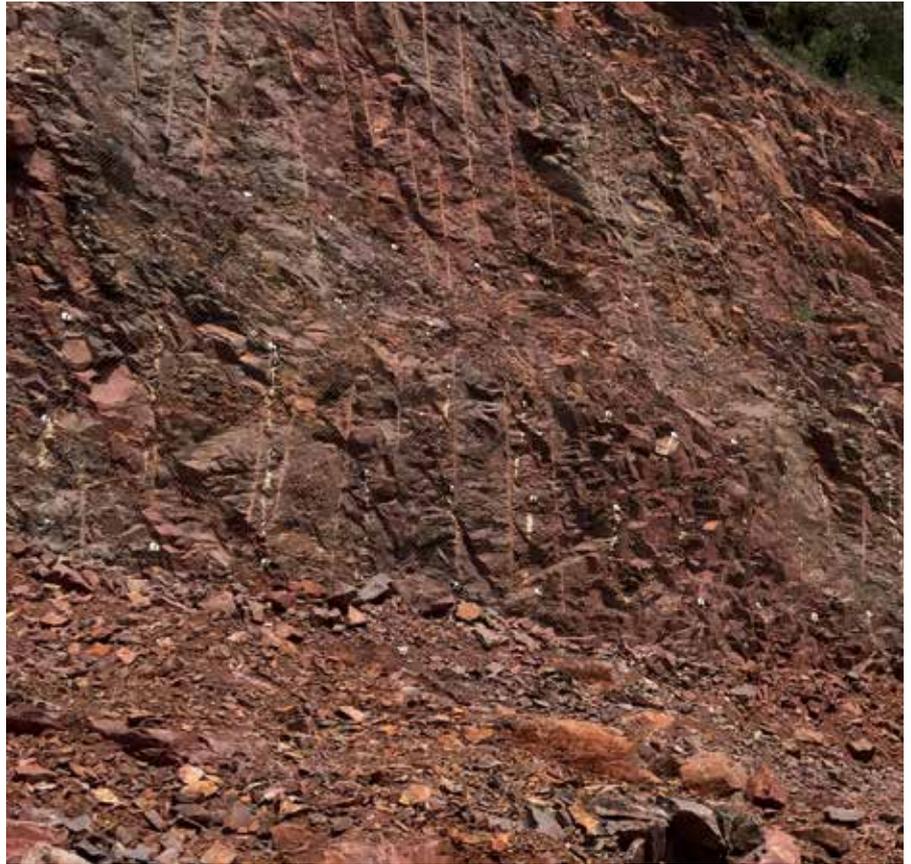
→ A second set of mesh, Tecco G65/2 was used over the Deltax mesh and longer dowels were used. Anchoring is a critical part of the slope stabilisation system and care should be taken that the downs are correctly installed and grouted. The length of the dowels should be sufficient so that nuts can be tensioned at 30 kN onto the baseplate. If this is not achievable one could consider increasing the length of the dowels. A staggered nail pattern (2 m x 2,5 m recommended) will also reduce the chances of boulders/rocks to slide behind the mesh over the total length of the slope.
